Re: NMFS Biological Opinion WCR-2016-4993, Monitoring Report

As required by conditions listed in the Biological Opinion for Electron Hydro Diversion Repair and Spillway Replacement, this document contains data consistent with section 2.9.3 Reasonable and Prudent Measures, and section 2.9.4 Terms and Conditions.

Attachment 5. Supporting Photographs

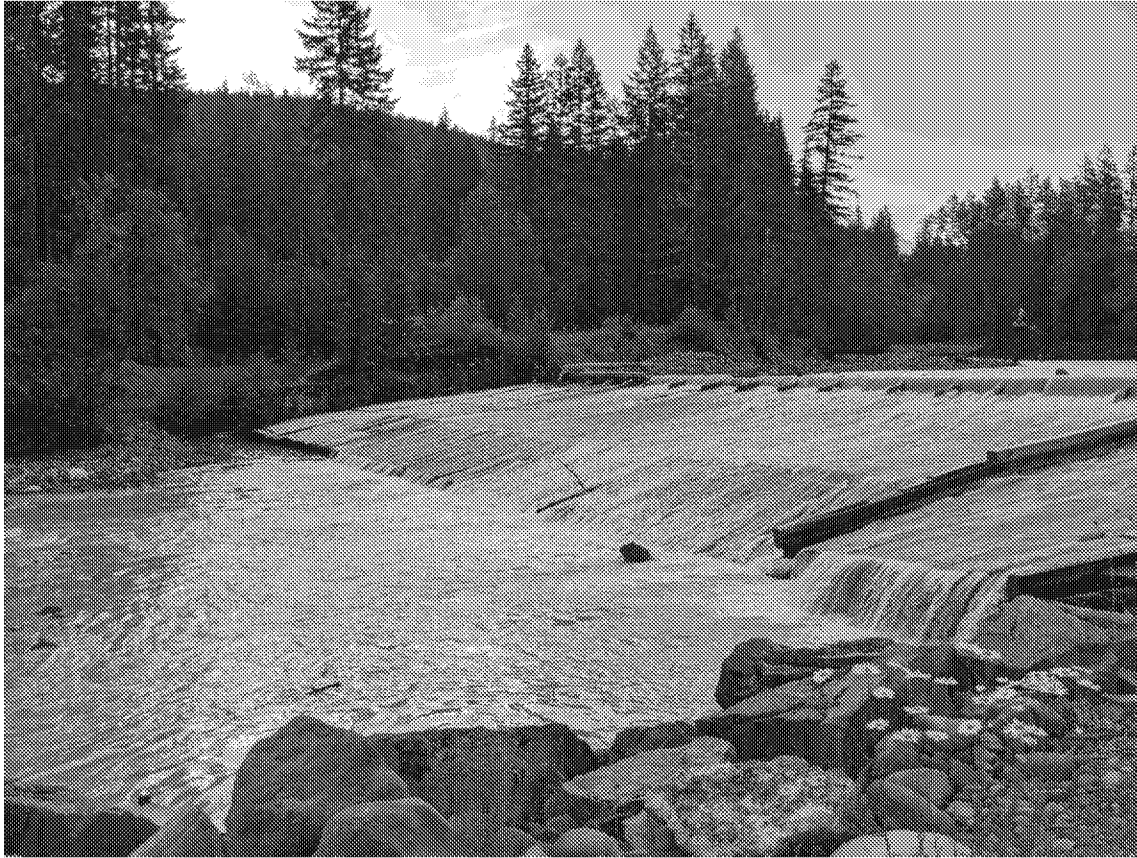
Spillway, Pre-Construction

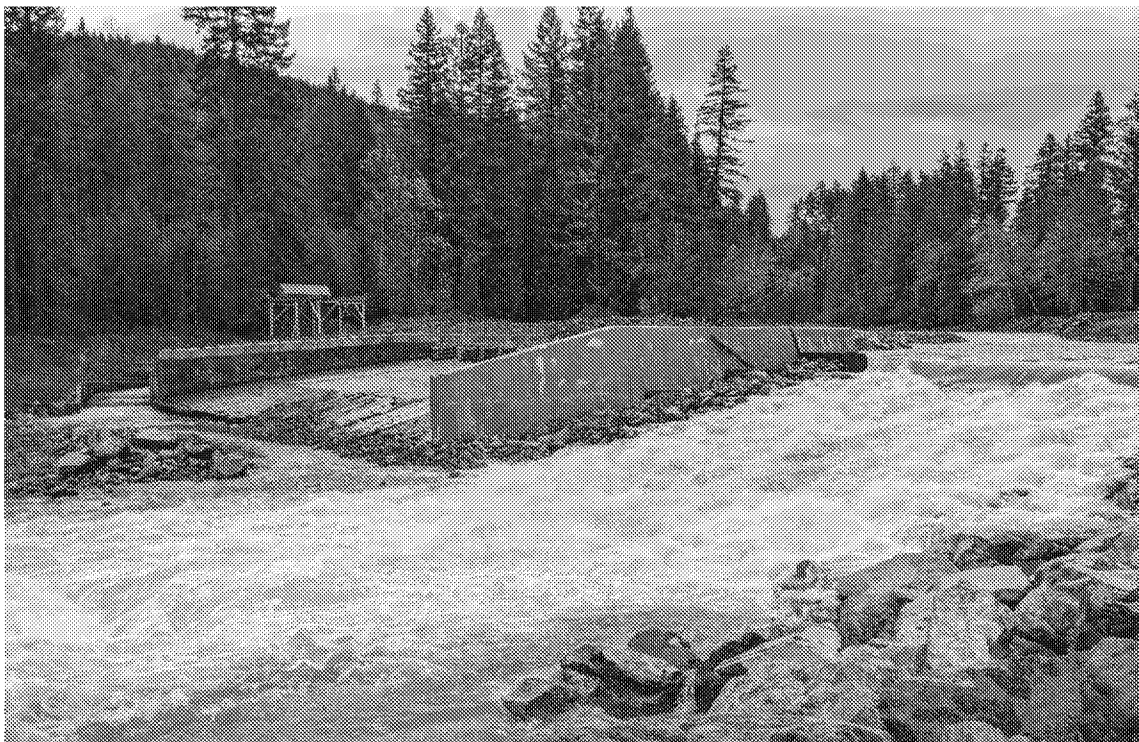
Spillway, Post-construction
